Mobile Intel[®] Pentium[®] II Processor Specification Update

Release Date: April 2002

Order Number: 243887-039

The Mobile Pentium[®] II processor may contain design defects or errors known as errata which may cause the product to deviate from published specifications. Current characterized errata are documented in this Specification Update.

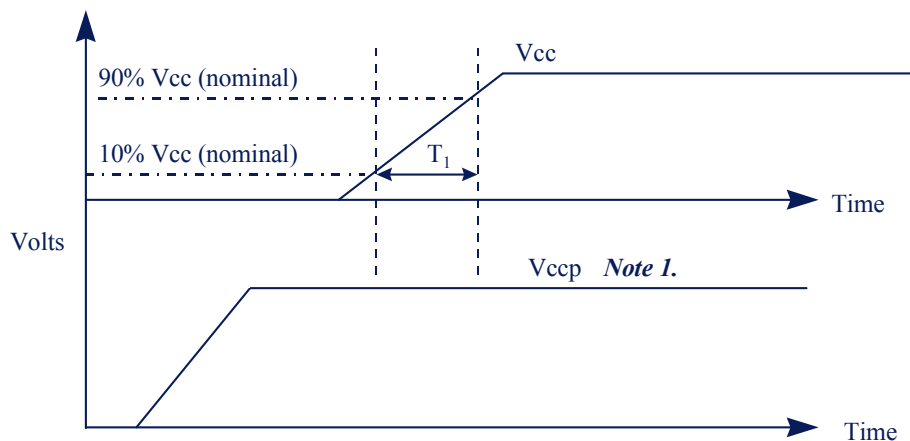
Figure 1. VCC/VCCP Timing Requirements (Mobile)

Problem: The processor uses the PWRGOOD signal to ensure that no voltage sequencing issues arise; no pin assertions should cause the processor to change its behavior until this signal is asserted, when all power supplies and clocks to the processor are valid and stable. However, if V_{CC} ramps up before V_{CCP} , it will cause the processor to enter an invalid state.

Implication: If this erratum occurs, the system may boot normally however, the L2 cache may not be initialized.

Workaround: For Mobile Pentium II processors, ensure that V_{CC} ramps after or with the L2 cache IO voltage (V_{CCP}). If V_{CCP} ramps after the V_{CC} , a delay circuit can be placed on the core V_{CC} to ensure that V_{CC} ramps at the same time or after V_{CCP} as shown below in Figure 1.

Symbol	Parameter	Min	Max	Notes
T_1	VCC Ramp Time	200 uSec		Measured between 10% VCC (nom) to 90% VCC (nom)
Note 1: VCCP must be greater than VCC during the interval in which VCC rises from 20% VCC to 80% VCC.
